METALS HANDBOOK

VOL. 9
FRACTOGRAPHY AND ATLAS OF FRACTOGRAPHY

8th EDITION

Fractography and Atlas of Fractographs

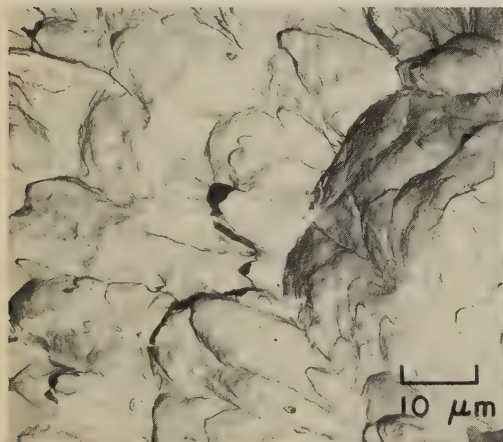
TEM fractograph (p-c replica)

1000×

4724 TEM replica of an area of the fracture surface of the specimen at center in 4722, which was broken in air at room temperature, showing a surface composed of elongated shear dimples.

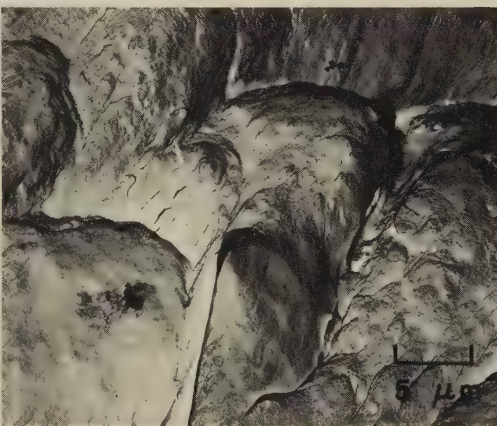
TEM fractograph (p-c replica)

2000×

4725 TEM replica of an area of the fracture surface of the specimen at left in 4722, which was tested in vacuum at 500 C (932 F). The dimples here are larger than those in 4724, reflecting the greater ductility at 500 C (932 F) than at room temperature.

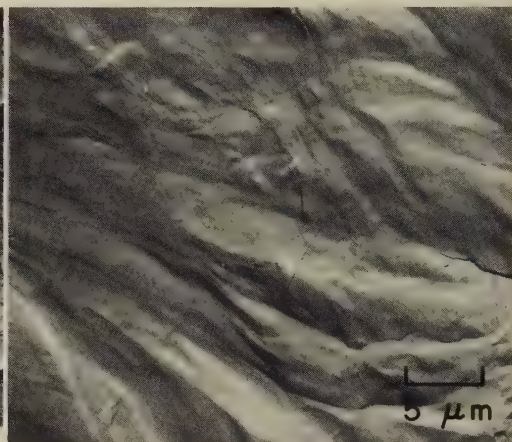
TEM fractograph (p-c replica)

2000×

4726 TEM replica of an area of the fracture surface of the specimen at right in 4722, which was tested in vacuum at 580 C (1076 F), showing only serpentine glide — the result of high ductility.

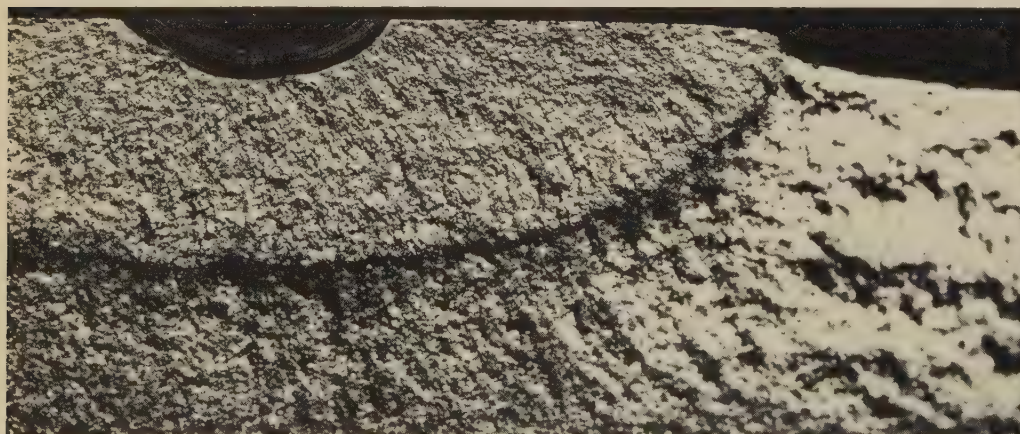
Light fractograph

1½×

4727 Surface of a low-cycle fatigue fracture in a Lehigh-type (notched) specimen of low-interstitial unalloyed titanium, photographed using low-angle illumination to provide maximum contrast. The specimen had been fatigue cracked in preparation for a fracture-toughness measurement, and no measurement of the actual fatigue stress was made. See 4728.

4728 TEM replica of an area of the fracture surface in 4727, showing typical fatigue striations, many of which exhibit deeply grooved fissures.

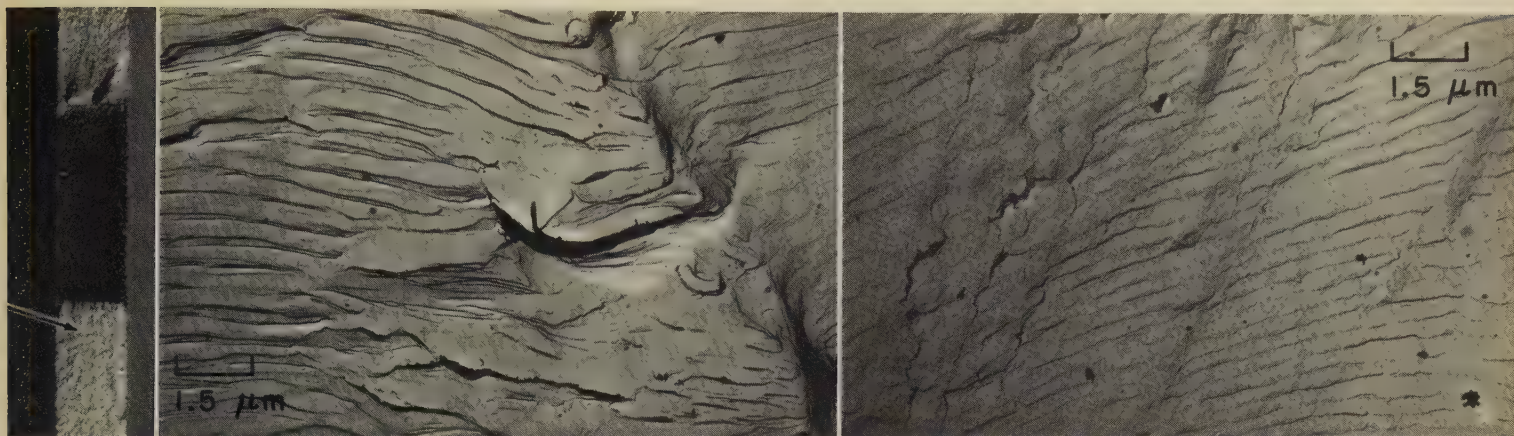
4729, 4730, 4731

Fractograph 4729 (left) shows a portion of the surface of a fatigue fracture in a centrally notched specimen (10 by 1.0 by 0.087 in. thick) of titanium alloy Ti-5Al-2.5Sn sheet annealed to a nominal tensile strength of 862 MPa (125 ksi). The notch was transverse, 0.01 in. in radius, and 0.25 in. long by sheet thickness. The specimen was loaded at room temperature to a stress cycled from 83 to 414 MPa (12 to 60 ksi) at 1000 cycles per minute and broken after 6200 cycles. At center (4730) is a TEM replica of an area at the arrow, adjacent to the notch, in 4729, showing sharply defined fatigue striations; at upper right in this view is a junction between two fatigue patches. At right (4731) is a TEM replica of another area at the arrow in 4729, showing a pattern of long, very regular fatigue striations that resulted from a single crack front. See also fractograph 4732.

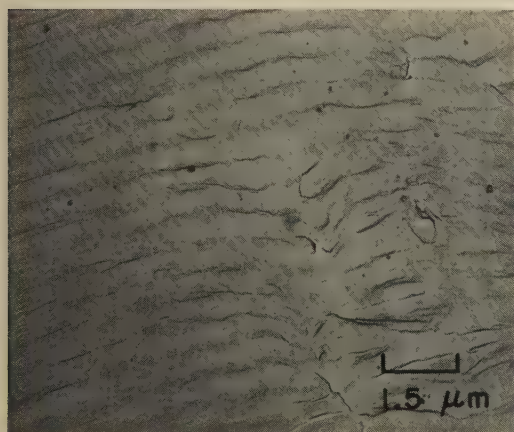
4732 TEM replica of a third area at the arrow in fractograph 4729, showing striation spacing similar to that in 4730 and wider than that in 4731. Faint suggestions of dimples are visible at right.

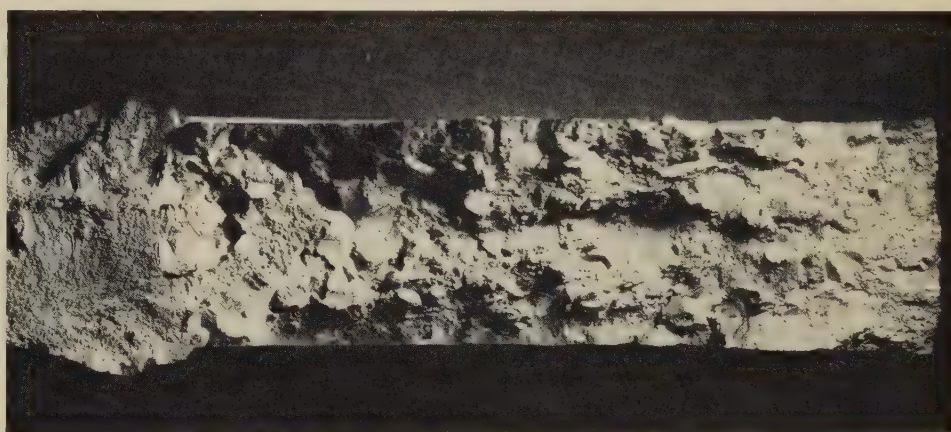
4733

Portion of the fracture surface of a drop-weight tear-test specimen of as-cast titanium alloy Ti-5Al-3Sn-2Mo-2V. It is clearly evident that in many areas fracture was intergranular, exposing the surfaces of some large grains. However, between these separated-grain facets, and particularly near the specimen surface, fracture was transgranular. See also fractographs 4734 to 4736, below.

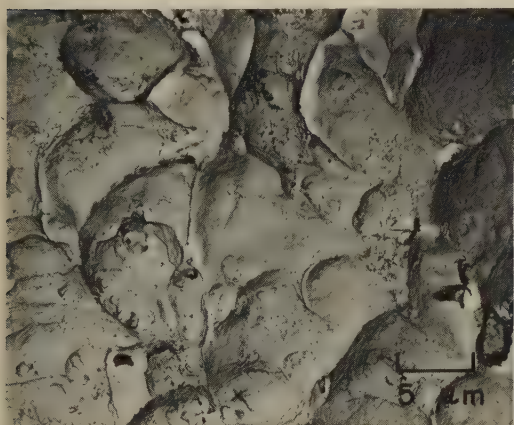
4734 TEM replica of a separated-grain facet in the fracture surface in 4733, showing tear dimples exhibiting relatively little of the elongation expected in such dimples.

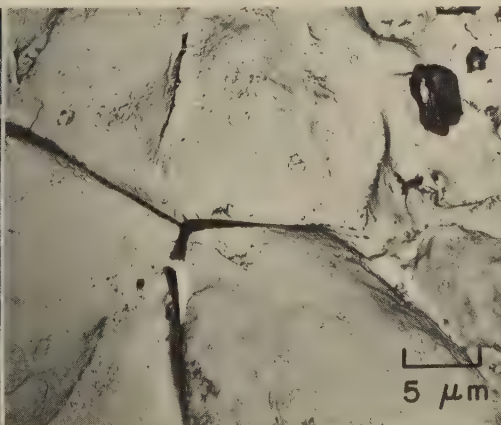
4735 TEM replica of a region of transgranular rupture in the fracture surface in 4733. This region exhibits quite large dimples with sharply defined boundaries.

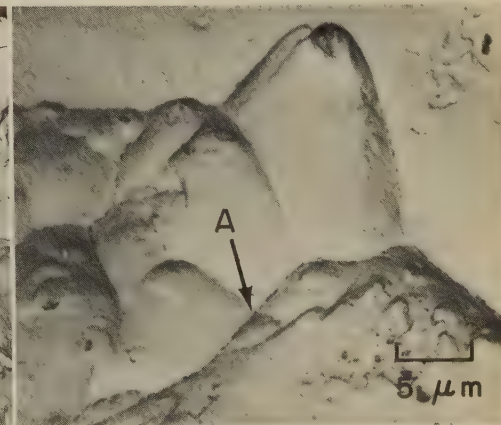
4736 TEM replica of another transgranular region of the fracture surface in 4733, showing tear dimples that do not overlap but that come together at points such as A.

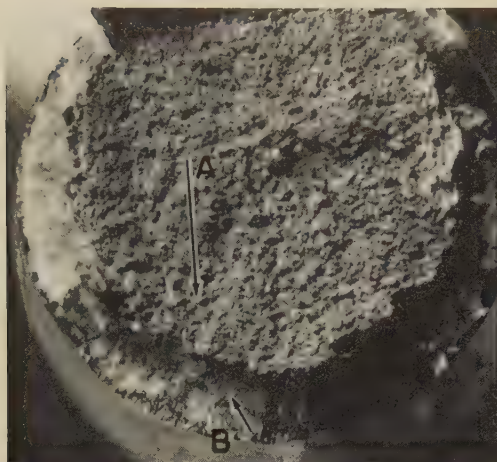
4737 Tension-overload fracture surface of an unnotched specimen of titanium alloy Ti-6Al-4V annealed to a tensile strength of 1062 MPa (154 ksi) and tested at -253 C (-423 F); fracture stress, 1820 MPa (264 ksi). See 4738 to 4740 for views at arrows.

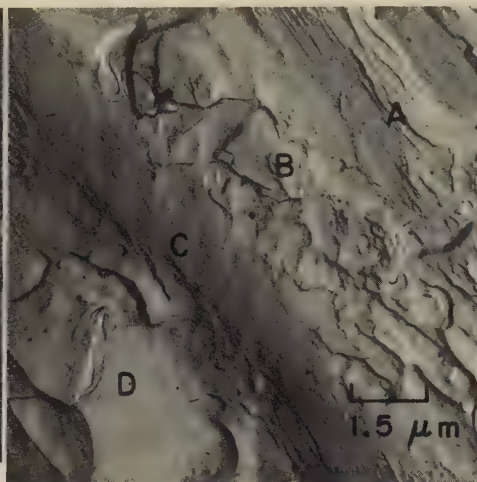
4738 TEM replica of an area at A in the fracture surface in 4737 (at left). Visible here are ripples (at A), small dimples (in the region marked B), stretched ripples (at C), and large dimples (at D).

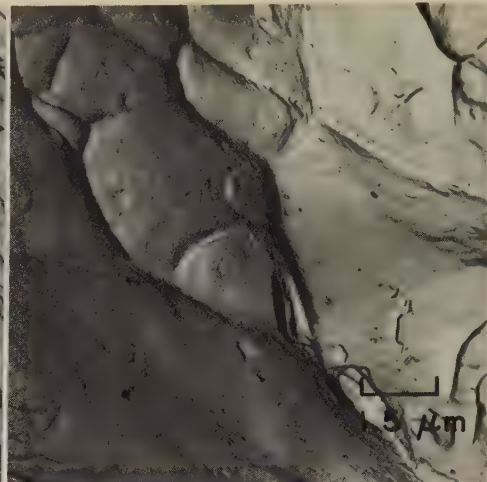
4739 TEM replica of another area at A in the fracture surface in 4737 (at far left). Dimples of moderate size are present at upper left, adjacent to very much larger dimples below and to the right.

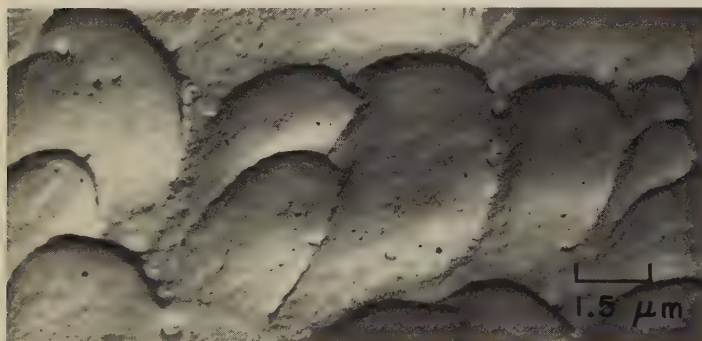
4740 TEM replica of an area at B in the shear lip of the fracture surface in 4737, showing an array of the large, uniform, well-developed shear dimples that are expected in this portion of the fracture surface.

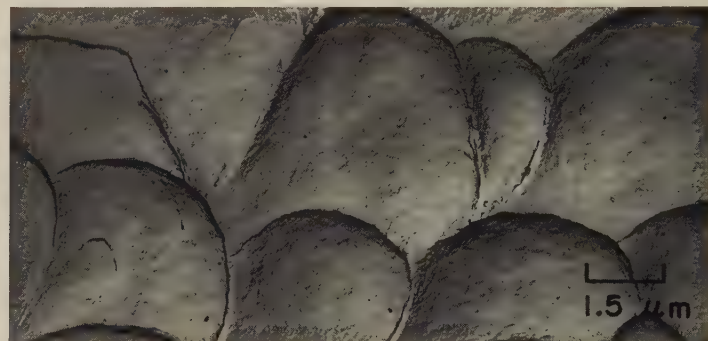
4741 TEM replica of an area at B near the edge of the fracture surface in 4742 (below, left), showing dimples, the elongation of which reflects the shearing action of the torsion test. See also 4743 and 4744.

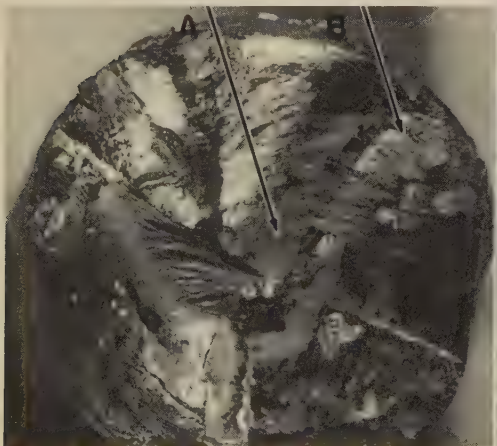
4742 Surface of a torsion-overload fracture in an unnotched specimen of titanium alloy Ti-6Al-4V solution treated at 954 C (1750 F), aged at 538 C (1000 F) to a tensile strength of 1186 MPa (172 ksi) and tested at room temperature. A jagged fracture surface. See also 4741, 4743 and 4744.

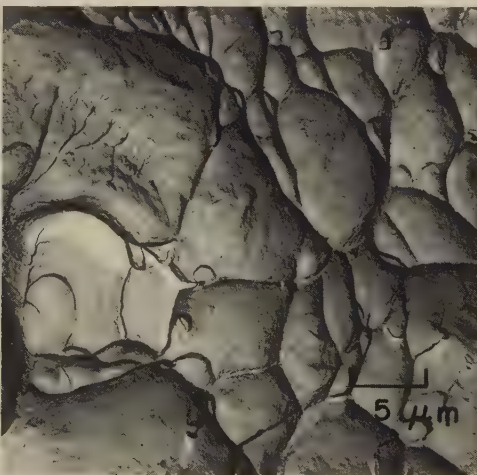
4743 TEM replica of an area at A in the center of the fracture surface in 4742. Equiaxed dimples of widely differing sizes are evident; these dimples are the result of tension that was produced as the final fracture occurred in bending.

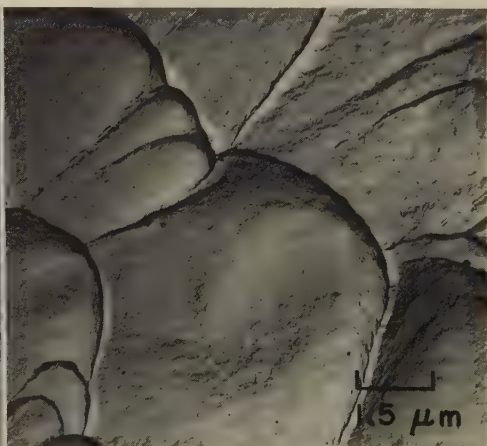
4744 TEM replica taken from another area at B near the edge of the fracture surface in 4742 (near the area shown in 4741, above). This area, like the one in 4741, exhibits the large and small elongated dimples that are expected in a torsion-overload fracture surface.

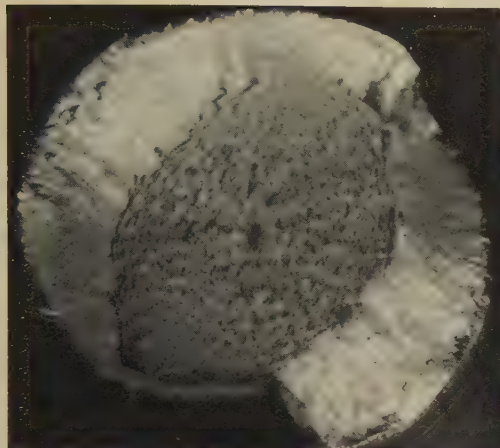
Light fractograph 9×
4745 Surface of a tension-overload fracture in an unnotched specimen of titanium alloy Ti-6Al-4V with a tensile strength of 1162 MPa (168.5 ksi). The flat, central region of the fracture surface is uniformly fibrous. See also 4746 to 4748.

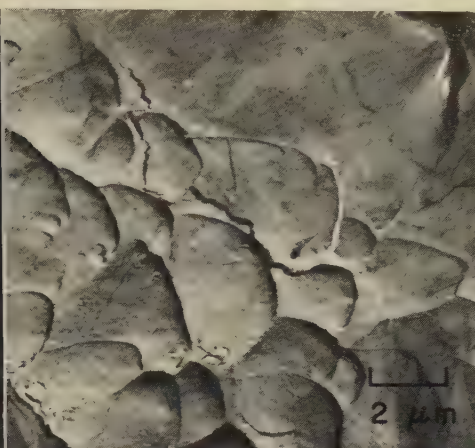
TEM fractograph (p-c replica) 5000×
4746 TEM replica of an area in the outer portion of the flat, central region of the fracture surface in 4745, showing somewhat elongated dimples. The large size and the smoothness of the dimple at top right suggest stretching.

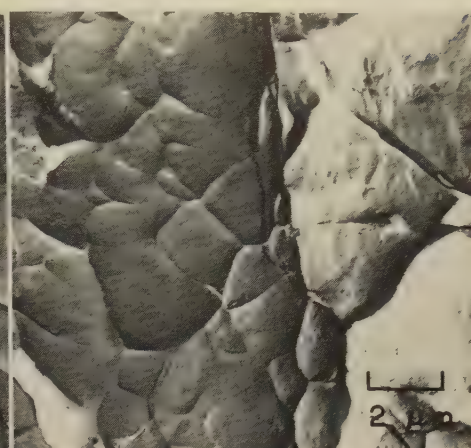
TEM fractograph (p-c replica) 5000×
4747 Another area in the flat, central region in 4745, with dimples more nearly equiaxed than those in 4746. What appears to be a grain boundary crosses the field just right of center; no evidence of secondary cracking at the boundary.

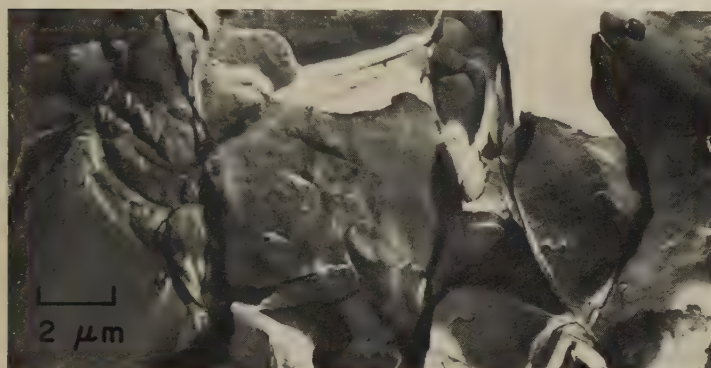
TEM fractograph (p-c replica) 5000×
4748 TEM replica of a third area in the flat, central region of the fracture surface in 4745, showing dimples of various shapes, which exhibit many regions that appear stretched. The white region at top right is a replica tear, not a void.

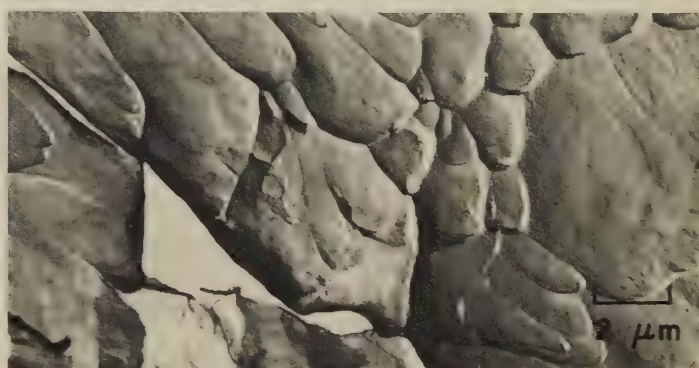
TEM fractograph (p-c replica) 5000×
4749 TEM replica of an area near the center of the fracture surface in 4750 (below, left), showing markedly elongated dimples, many of which are very flat. A secondary crack extends from top left to bottom center.

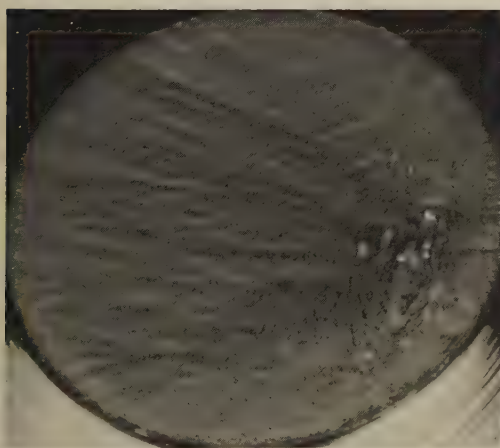
Light fractograph 9×
4750 Surface of a tension-overload fracture in a notched specimen of titanium alloy Ti-6Al-4V with a tensile strength of 1696 MPa (246 ksi). Unnotched tensile strength, same as in 4745. Fibrous marks radiate from the subsurface fracture origin at right. See 4749, 4751 and 4752.

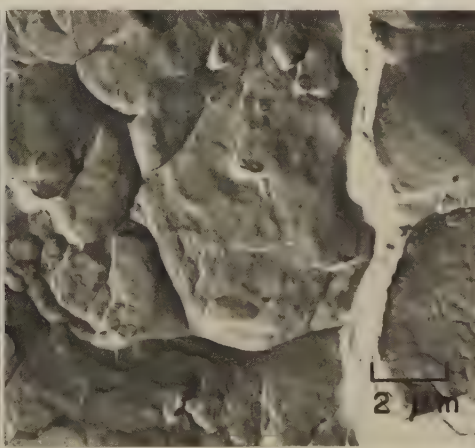
TEM fractograph (p-c replica) 5000×
4751 TEM replica of an area near the center of the fracture surface in 4750 — an area different from the one shown in 4749 (above, at right). The white vertical feature is either a secondary crack or a sharp step. The dimple at top right shows stretching and ripples.

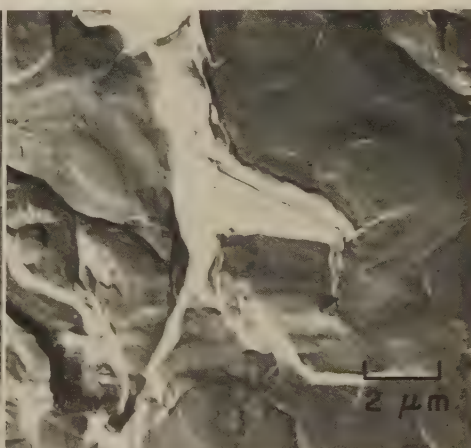
TEM fractograph (p-c replica) 5000×
4752 TEM replica of a third area near the center of the fracture surface in 4750, showing branched secondary cracks (white). The dimples in the upper portion of the field have undergone appreciable stretching and display faint ripples.

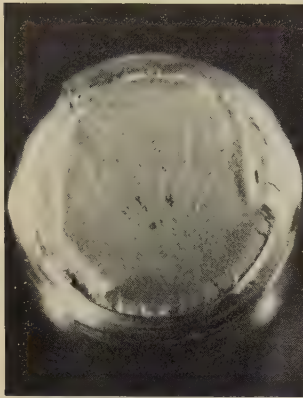
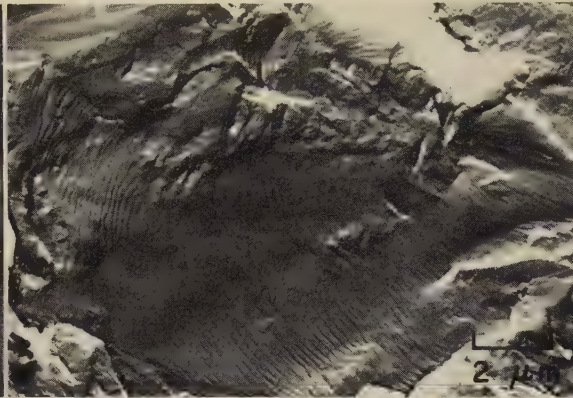
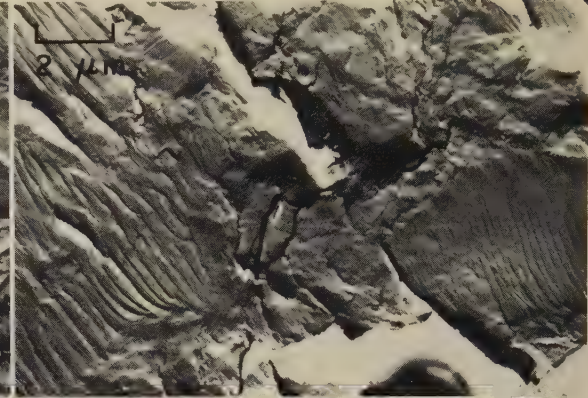
Light fractograph 6×
4753, 4754, 4755

Fractograph 4753 (left) shows the surface of a low-cycle fatigue fracture in a threaded bolt of titanium alloy Ti-6Al-4V, with a tensile strength of 1162 MPa (168.5 ksi), that was tested in tension-tension ($R = 0.1$) at a maximum stress of 689 MPa (100 ksi) and that broke after 12,000 cycles. The fatigue crack began at several nuclei in the root of the thread. Formation of the smooth fatigue zone at lower right was succeeded by formation of the zone of fibrous fast fracture, in which the fibers are radially oriented. Fractographs 4754 (center) and 4755 (right) are TEM replicas of two areas in the fatigue zone and show sharply defined fatigue striations that vary in orientation. The area shown in 4755 is farther from the crack nuclei than the area shown in 4754 and displays wider striation spacing. See also fractograph 4756 (below, at left).

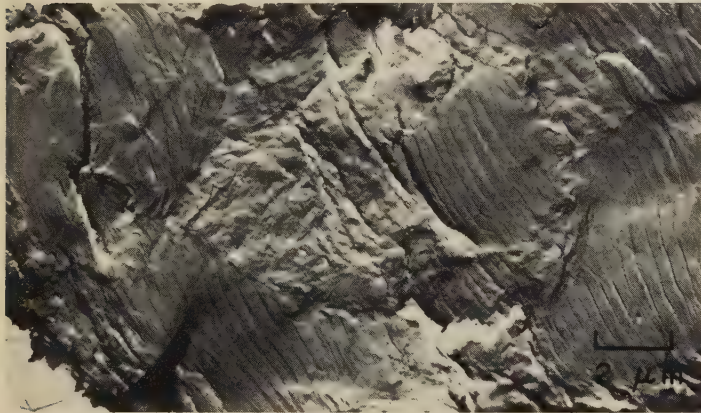
4756 TEM replica of an area of the fracture surface in 4753 still farther from the fatigue-crack nuclei than the areas in 4754 and 4755 and showing still wider spacing of fatigue striations. The facet at left center is essentially free of striations because of unfavorable crystallographic alignment.

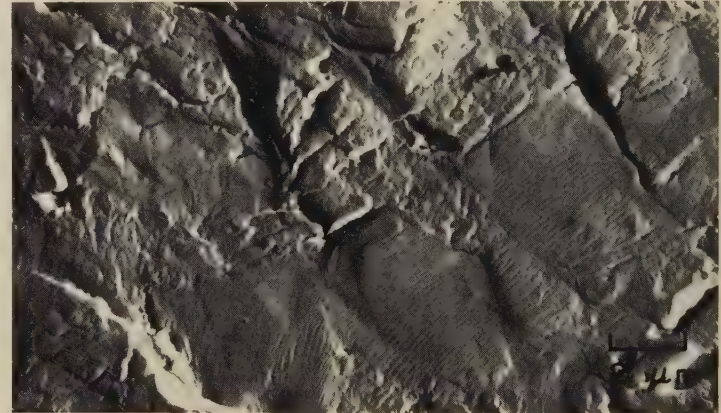
4757 TEM replica of a fatigue-zone area of the fracture in 4758 (below, left). Striations here are much finer than those in the low-cycle fatigue-test specimen in 4753 to 4756, which was broken at higher stress. Numerous facets lack striations because of unfavorable crystallographic orientation.

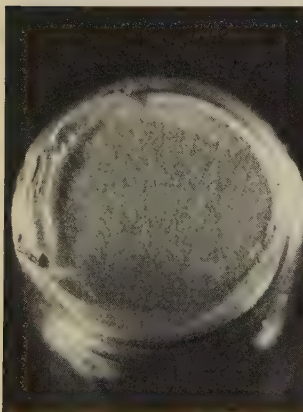
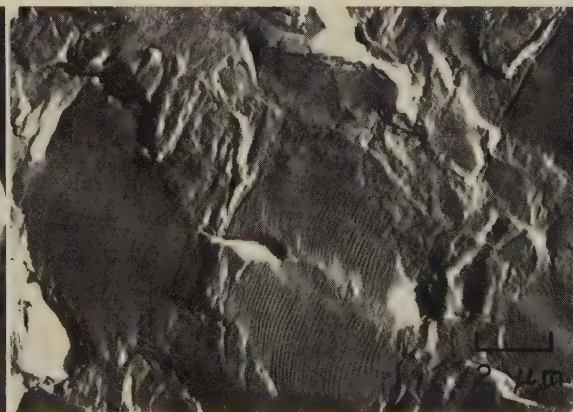
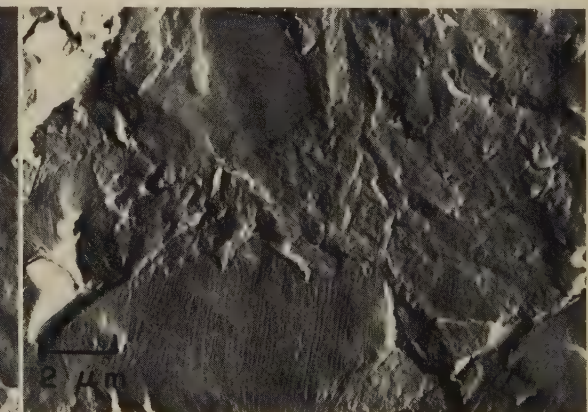
Light fractograph 6×
4758, 4759, 4760

Fractograph 4758 (left) shows the surface of a high-cycle fatigue fracture in a threaded bolt of titanium alloy Ti-6Al-4V, with the same tensile strength as that of the bolt in 4753, that was tested in tension-tension ($R = 0.1$) at a maximum stress of 345 MPa (50 ksi). Fracture occurred after 937,000 cycles. The fatigue crack originated on a broad front at nuclei in the root of the thread. Fractographs at center (4759) and right (4760) are TEM replicas of two areas in the fatigue zone; in both areas, about half of the facets show no striations and the striations in adjacent facets display different orientations. Some secondary cracking has occurred here but is not clearly visible except at top in 4759. See also fractograph 4757 (above, right).

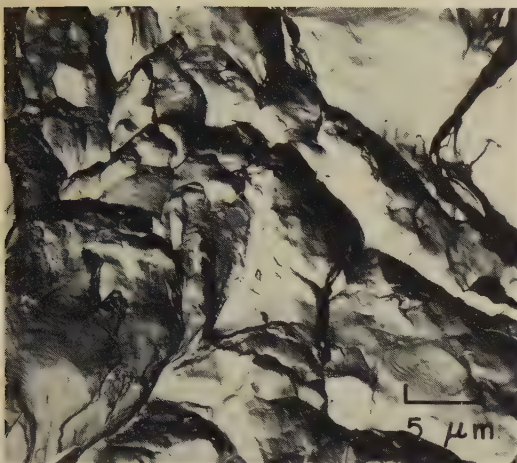
4761 TEM replica of the surface of a room-temperature tension-overload fracture in a specimen of titanium alloy Ti-6Al-4V, showing dimples in a wide range of sizes. Note ripple marks, throughout, which could be mistaken for fatigue striations.

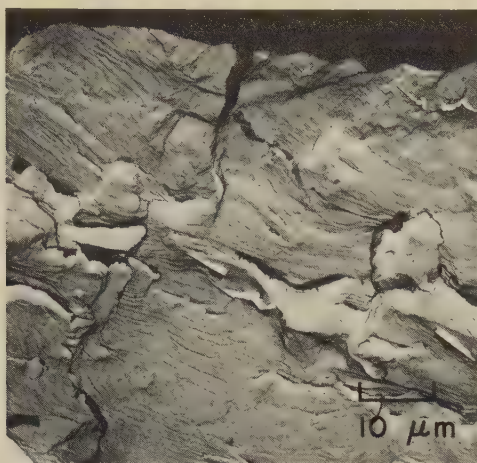
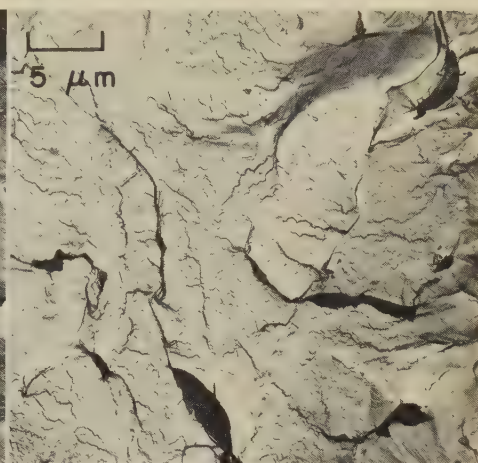
4762, 4763 TEM replicas of two areas of the fracture surface in 4765 (below, right) — a low-cycle fatigue fracture in titanium alloy Ti-7Al-2Cb-1Ta. Fractograph 4762 (left), of an area at A in the fatigue zone, shows a distorted surface with pronounced fissures between patches of fatigue striations. Fractograph 4763 (right), of an area at B, at the transition between fatigue and tension-overload fracture, shows quasicleavage facets containing small cleavage steps or tear ridges.

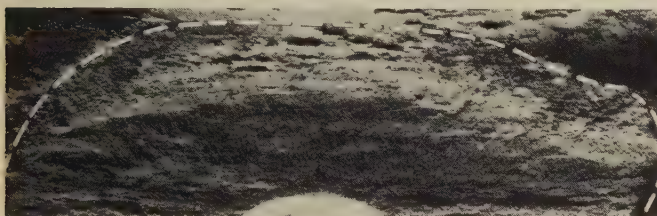
4764 Surface of a low-cycle fatigue fracture in a center-notched-plate bend specimen of titanium alloy Ti-7Al-2Cb-1Ta, mill annealed, tested in distilled water. The fatigue-crack surface (outlined by dashed line) was exposed by tension overload. See also fractograph 4766 (below, left), for a TEM view of an area of this fracture surface.

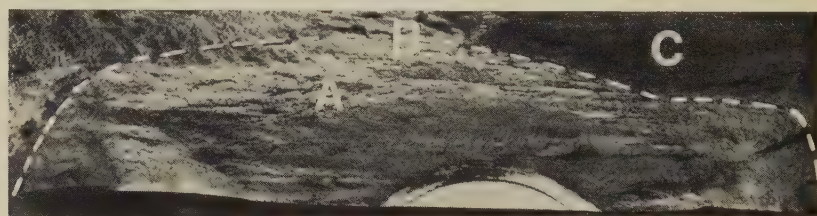
4765 Surface of a low-cycle fatigue fracture in a specimen of Ti-7Al-2Cb-1Ta alloy similar to that in 4764 but tested in ambient air. The rate of crack growth here was lower than that for the specimen in 4764 (tested in distilled water), and the rate for the specimen in 4764 was lower than that for the specimen in 4767 below (tested in salt water). See 4762, 4763 and 4769 for TEM replicas of areas at A, B and C.

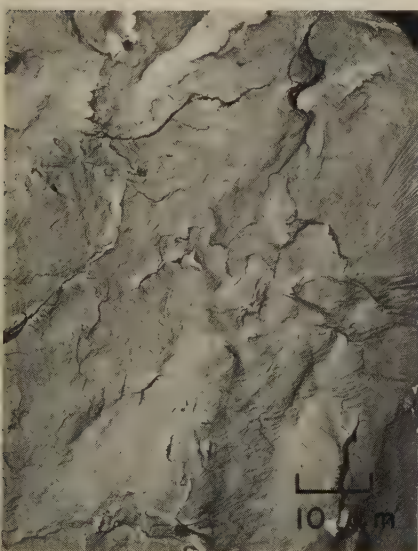
4766 A TEM replica of an area of the surface of the low-cycle fatigue fracture in fractograph 4764 (above), showing quasicleavage facets at left and, at right, facets containing fatigue striations.

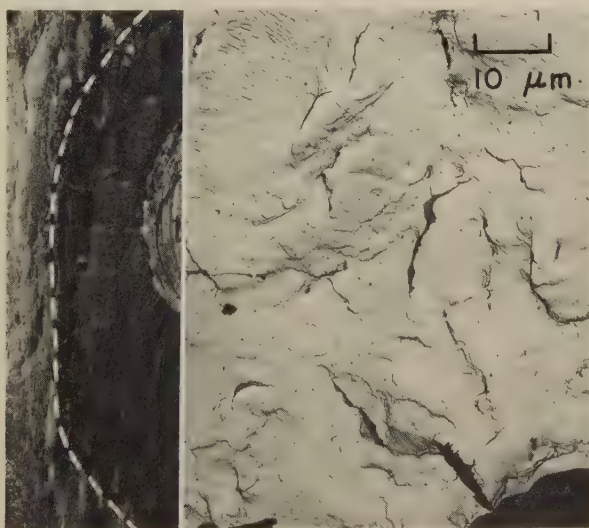
4767, 4768 Fractograph 4767 (left) shows a corrosion-fatigue fracture in a titanium alloy Ti-7Al-2Cb-1Ta specimen similar to those in 4764 and 4765 except tested in salt water. Fractograph 4768 (right) is a plastic-carbon replica of the fatigue zone in 4767 showing fatigue striations at top and quasicleavage facets at bottom.

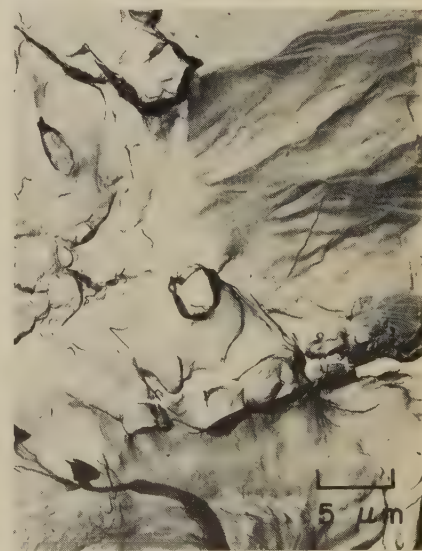
4769 TEM replica of an area at C in the tension-overload region of the fracture surface in 4765 (above), showing large and small dimples at left and serpentine glide at top right and bottom right.

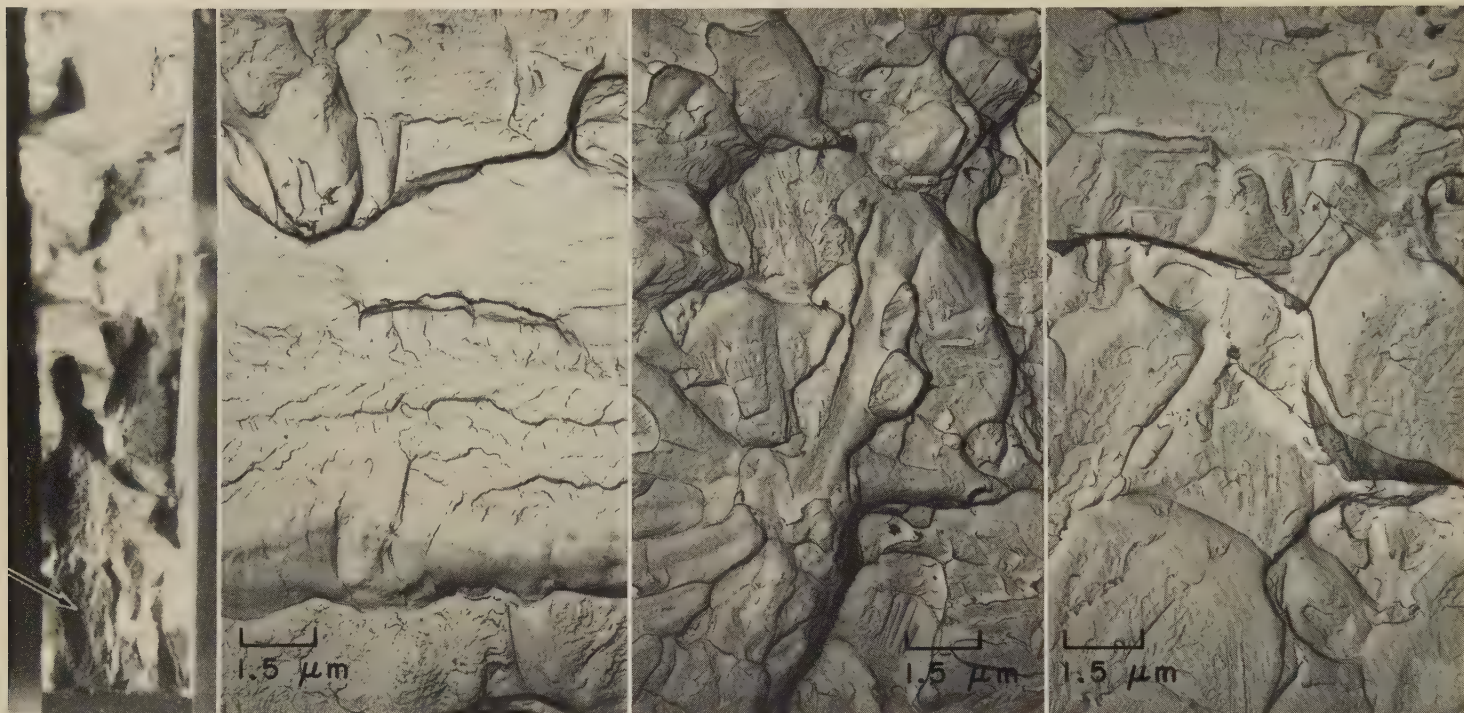
4770, 4771, 4772, 4773 Fractograph 4770 (left) shows the surface of a sustained-tension fracture in a notched specimen of titanium alloy Ti-8Mn sheet (annealed to a tensile strength of 896 MPa or 130 ksi) that was charged with hydrogen at 704 C (1300 F) to 480 ppm and tested at room temperature at a stress of 834 MPa (121 ksi). Fracture occurred after 24 hr. Specimen was notched at both edges, at center of flat gage section ($1\frac{3}{16}$ by 0.25 by 0.045 in.). Notches had angles of 60°, and were 0.05 in. deep and 0.005 in. in radius. Fractographs 4771 to 4773 are TEM replicas of three areas at the arrow (near notch at bottom) in 4770. In 4771 (second from left), a large region of cleavage is bordered by dimple-like features. Fractographs 4772 (second from right) and 4773 (right) show flattened features with aspects of combined cleavage and microvoid coalescence, or "quasicleavage".

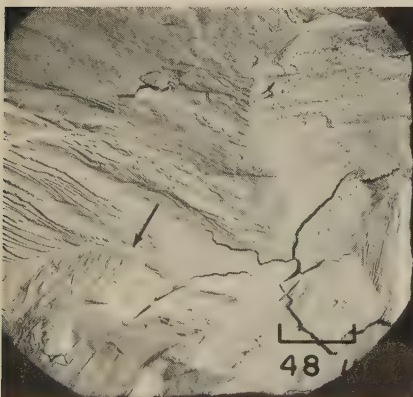
TEM fractograph (p-c replica)

4775, 4776 Fractograph 4775 (at far left) is a TEM view of a replica of an area of the fracture surface shown in 4774 (at left above). This area exhibits cleavage-like steps, which halt at grain boundaries (arrow). The fatigue striations in this area are much finer than are the more readily visible cleavage-like steps.

4774 This light fractograph (at left) shows the major portion of the surface of a fatigue fracture in a center-notched specimen of titanium alloy Ti-13V-11Cr-4Al sheet aged at 454 C (850 F) and loaded in tension-tension, at room temperature, to a stress cycled from 62 to 124 MPa (9 to 18 ksi). The specimen broke after 23,000 cycles. See fractographs 4775 and 4776, below.

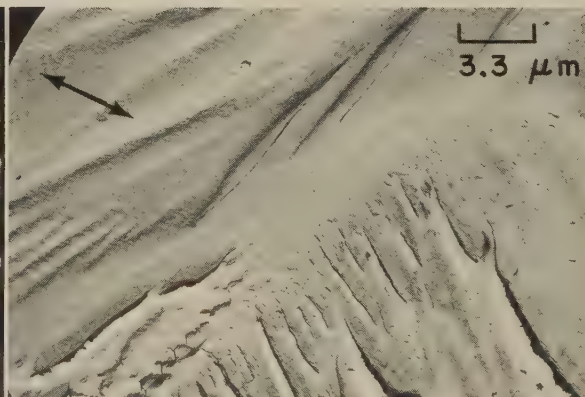
TEM fractograph (p-c replica)

Fractograph 4776 (at near left) is a higher-magnification TEM view of a replica of an area at the arrow in 4775, showing extremely fine fatigue striations (parallel with the double-headed arrow), which cross other sets of lines that are analogous to cleavage steps.

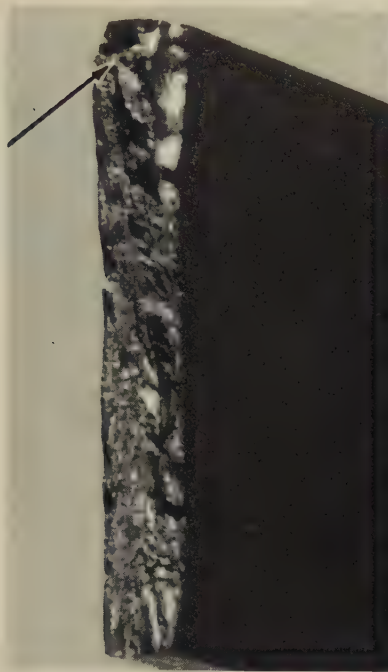
Light fractograph

4777 Tension-overload fracture in a notched specimen (12 by 0.50 by 0.063 in.) of stress-relieved, commercially pure tungsten sheet (tensile strength, 1103 to 1517 MPa or 160 to 220 ksi) that broke at a stress of 690 MPa (100 ksi), showing jagged, step-like facets. Notch was saw cut to a depth of 0.05 in. See 4778-4780.

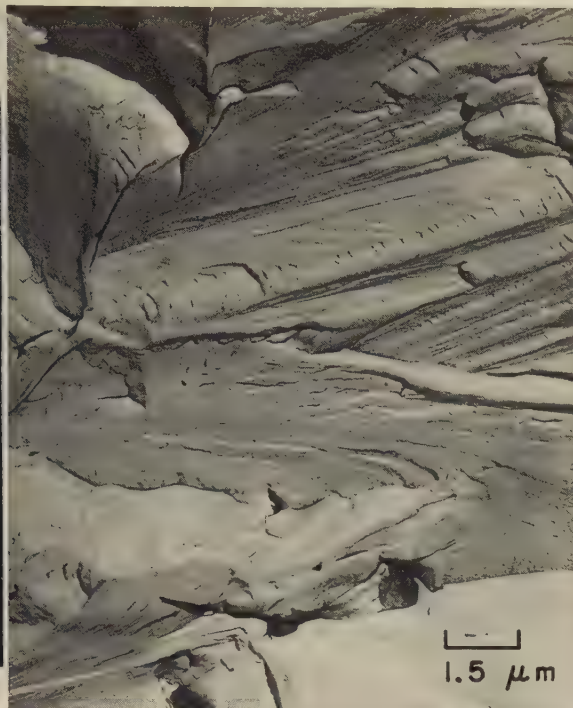
TEM fractograph (p-c replica)

4778 TEM replica of an area at the arrow in the fracture surface in 4777 (left), showing transgranular cleavage facets containing cleavage feathers. The facets at bottom may have resulted from local intergranular rupture.

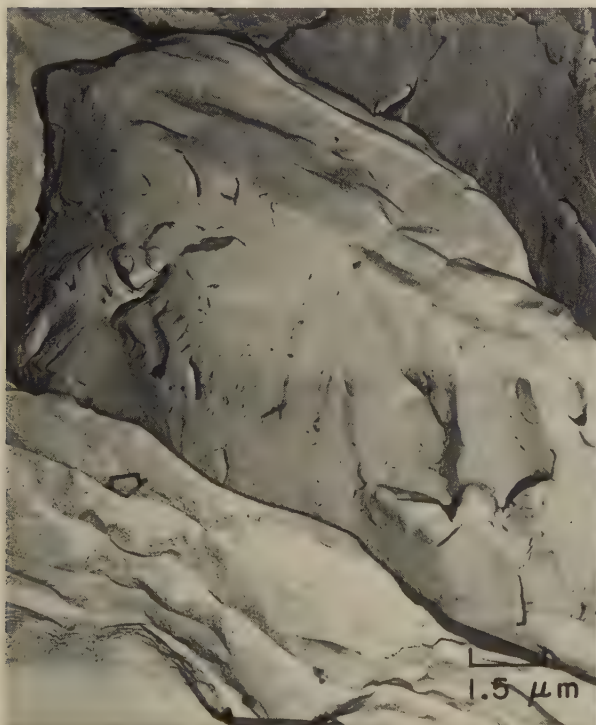
TEM fractograph (p-c replica)

4779 TEM replica of a second area at the arrow in the tension-overload fracture surface in 4777. Cleavage facets are evident at top. A region of intergranular rupture is visible at arrow.

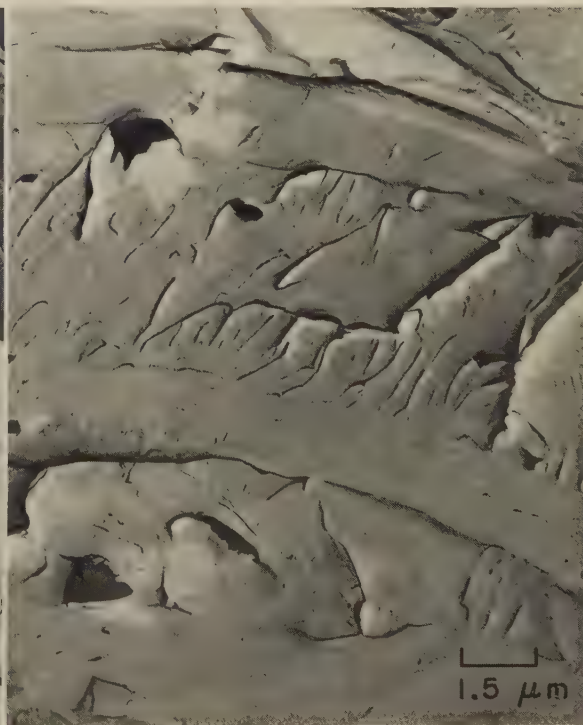
TEM fractograph (p-c replica)

4780 TEM replica of a third area at the arrow in the fracture surface in 4777. Cleavage features are predominant here. However, the narrow facet at top may be a separated-grain facet.

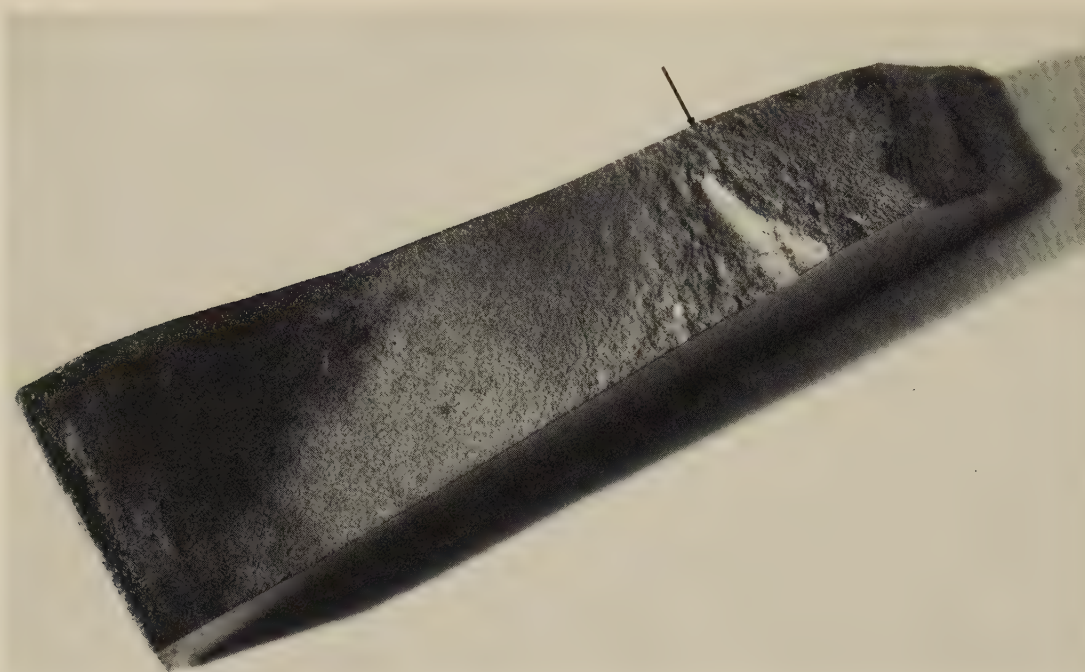
Light fractograph

4781 Exposed surface of a crack in a rocket-nozzle insert made of tungsten powder sintered to 70 to 80% of theoretical density. The crack, observed after only 30 sec of test-stand firing, was attributed to thermal shock. The crack was perpendicular to the nozzle axis and extended through about two-thirds of the wall of the insert; shown here is a thin slice of the wall. The crack propagated from left to right in this view, ending at the arrow by the bright facet. The remainder of the fracture was produced in the laboratory to expose the crack surface. See 4782 to 4784, below.

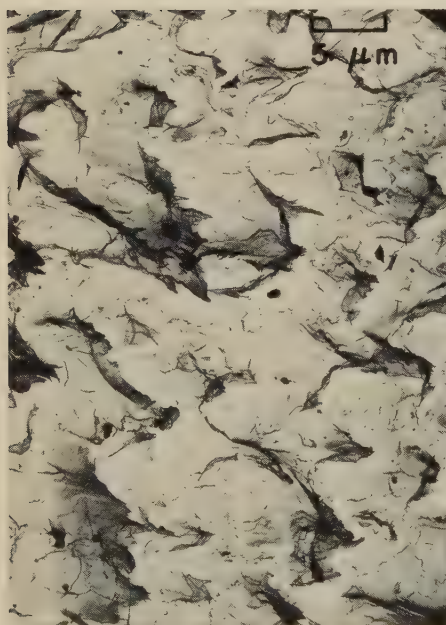
TEM fractograph (p-c replica)

4782 TEM replica of an area in the portion of the fracture in 4781 that occurred during test-stand firing, showing intergranular facets of approximately the same size as the size of the particles of tungsten powder.

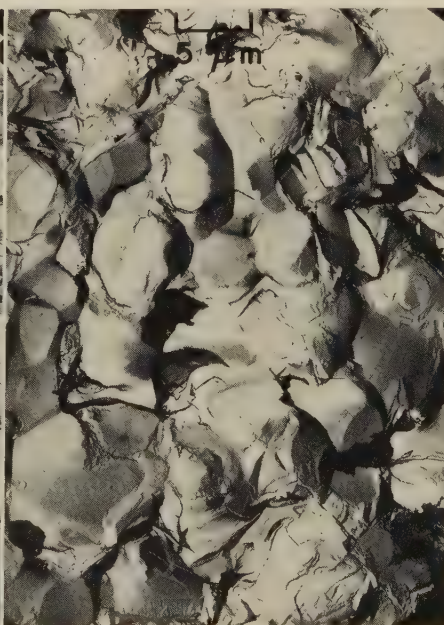
TEM fractograph (p-c replica)

4783 TEM replica of an area in the portion of the fracture in 4781 that was produced in the laboratory. This area, like that in 4782, shows intergranular facets of about the same size as the particles of tungsten powder.

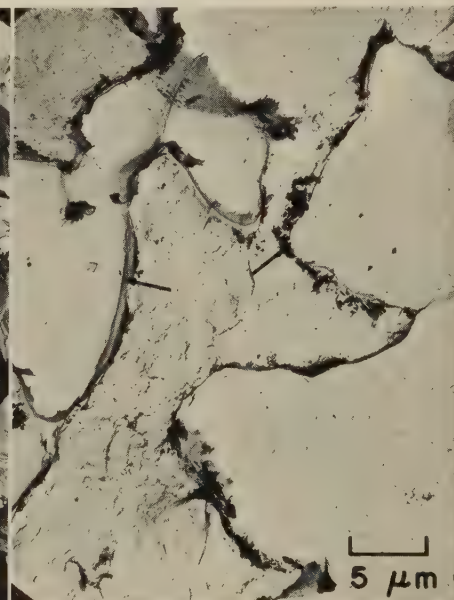
TEM micrograph (Kroll's reagent)

4784 Plastic-carbon TEM replica of a polished and etched section through the test-stand-firing portion of the crack in 4781. The crack (lower left to upper right) is filled with epoxy resin; crack surfaces (arrows) do not abut because of plastic flow.

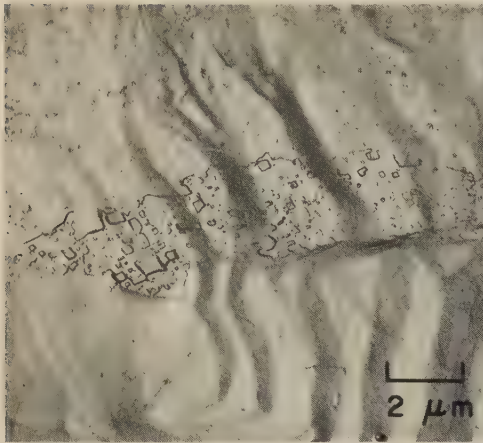
TEM micrograph (p-c replica) 5000×
4785 External surface of a specimen of Armco iron that had been etch-pitted and then subjected to tension during one cycle of a 2.5° bend test. Note the slip steps. See also micrograph 4786.

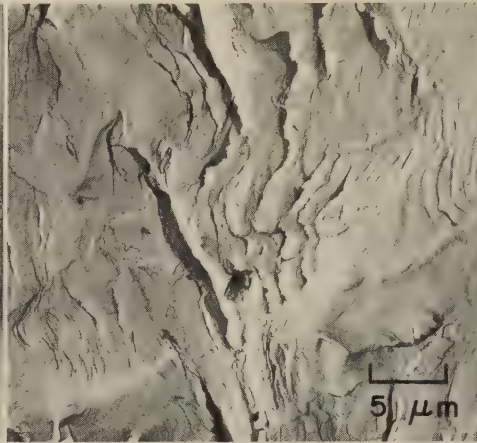
TEM micrograph (p-c replica) 2000×
4786 Same specimen as in 4785 after 5½ cycles of 2.5° bending. At center is the same area as in 4785 (reversed left to right in printing), showing slip-band cracks that have grown at slip steps.

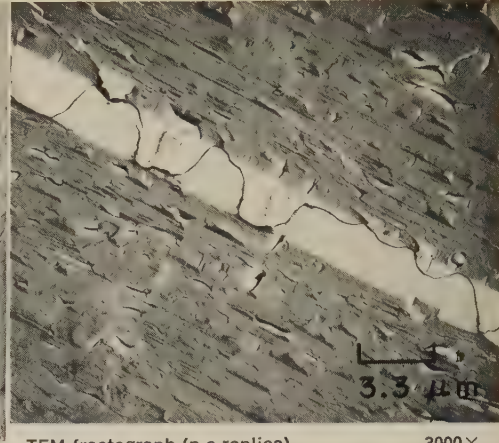
TEM fractograph (p-c replica) 3000×
4787 Cleavage fracture in Armco iron broken at dry-ice temperature (−78.5 C; −109.3 F). The light band shows where cleavage followed a twin-matrix interface. The black meandering line is a shear step through the thickness of the twin.

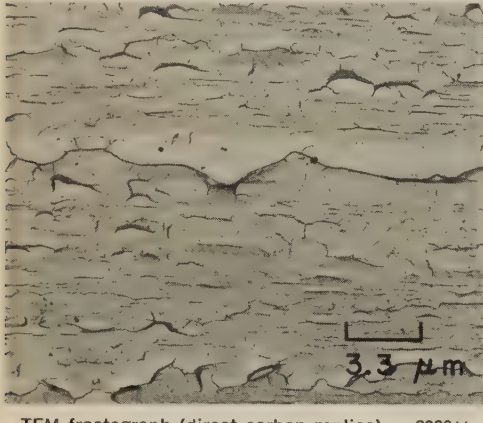
TEM fractograph (direct carbon replica) 3000×
4788 Cleavage fracture in Armco iron broken at dry-ice temperature (−78.5 C; −109.3 F), showing facets of which most have the same orientation. Facets that depart from the general orientation appear lighter or darker than the majority.

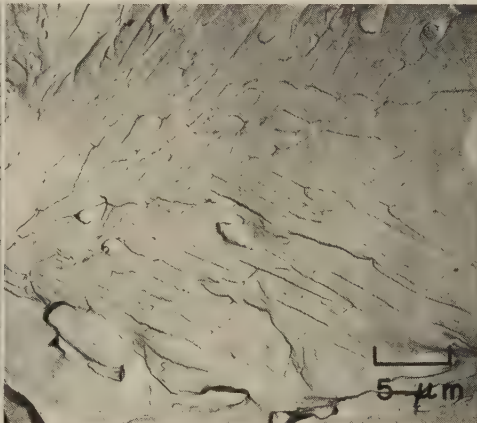
TEM fractograph (p-c replica) 2000×
4789 Cleavage fracture in Armco iron broken at −45 C (−49 F). Instead of cleavage steps, tear ridges (occasionally forming river patterns) were produced here by microscopic plastic flow.

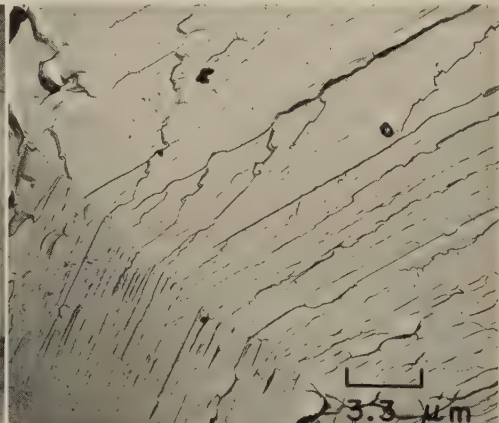
TEM fractograph (p-c replica) 3000×
4790 Cleavage fracture in Armco iron broken at −196 C (−321 F), showing river patterns, tongues and (from bottom right to top left) a grain boundary.

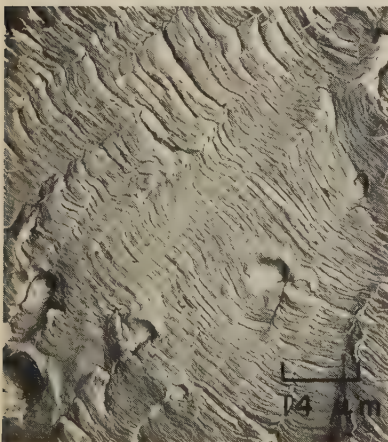
TEM fractograph (p-c replica) 700×
4791 Surface of a fatigue fracture in Armco iron, exhibiting fatigue striations and inclusion-matrix interfaces.

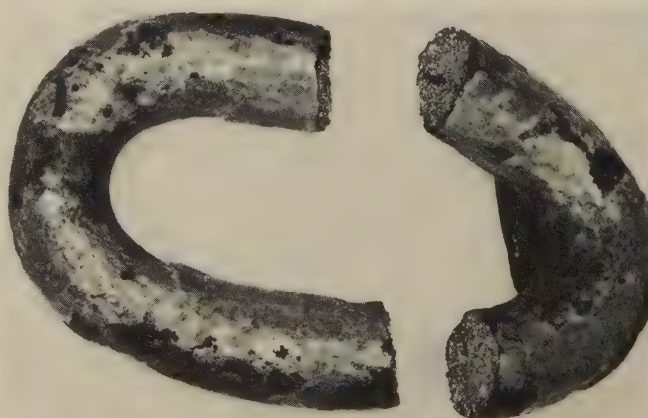
Photograph 1.9×
4792 Wrought iron chain link from a guardrail, fractured by impact in cold weather (2 C; 36 F). Examination of the fracture surfaces disclosed no evidence of prior cracking or of metallurgical defects. See 4793.

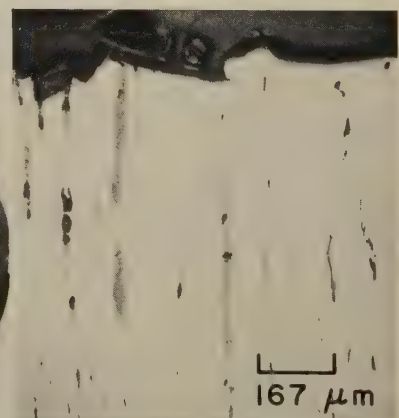
Micrograph (2% nital) 60×
4793 Polished and etched section normal to a fracture surface in 4792, showing the surface in profile at top. Note lack of deformation of cleaved grains.

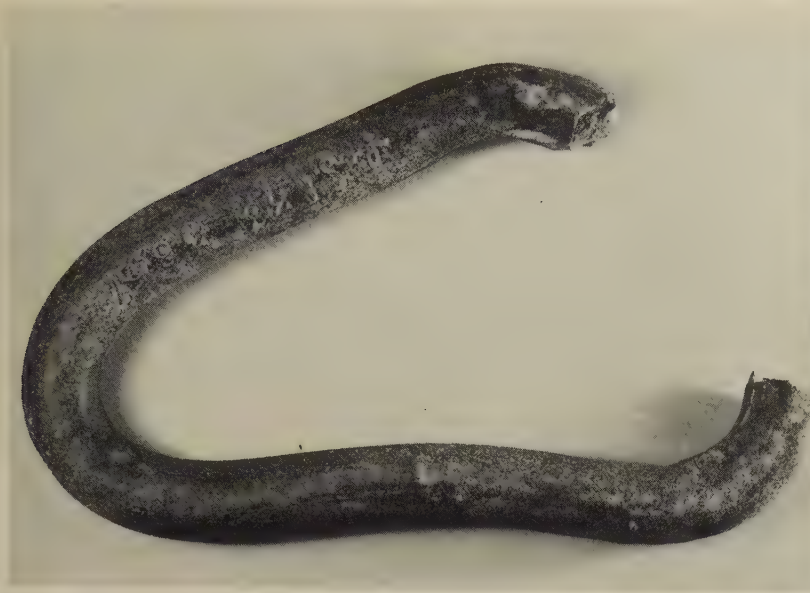
Photograph
4794 A 6-in.-long chain link made of galvanized $\frac{3}{8}$ -in.-diam steel rod that fractured at an imperfectly welded joint. No other defects were discovered. See also fractograph 4795.

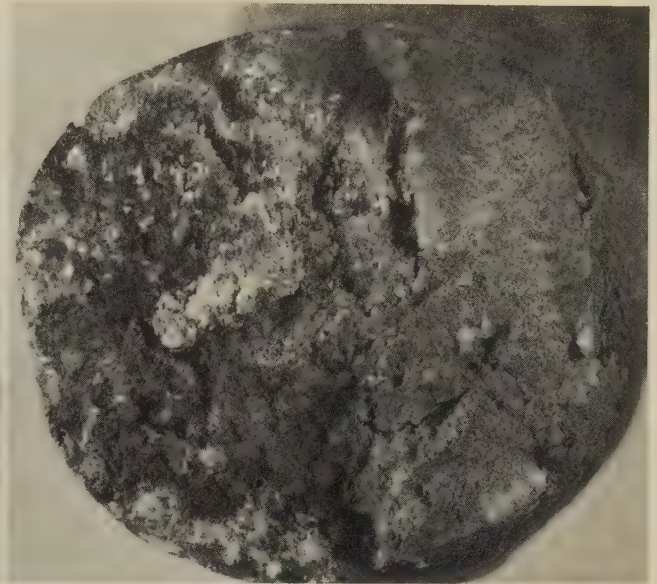
Light fractograph
4795 A view of a fracture surface of the chain link in 4794, showing discolored, undeformed areas indicative of incomplete fusion during welding.
